Research Report  
UKTRP-86-25

RUTTING AND LONGITUDINAL CRACKING  
AND TEMPERATURE CRACKING  
A CASE STUDY

(US 23, Greenup County, MP 6.0 to 28.8)

November 1986

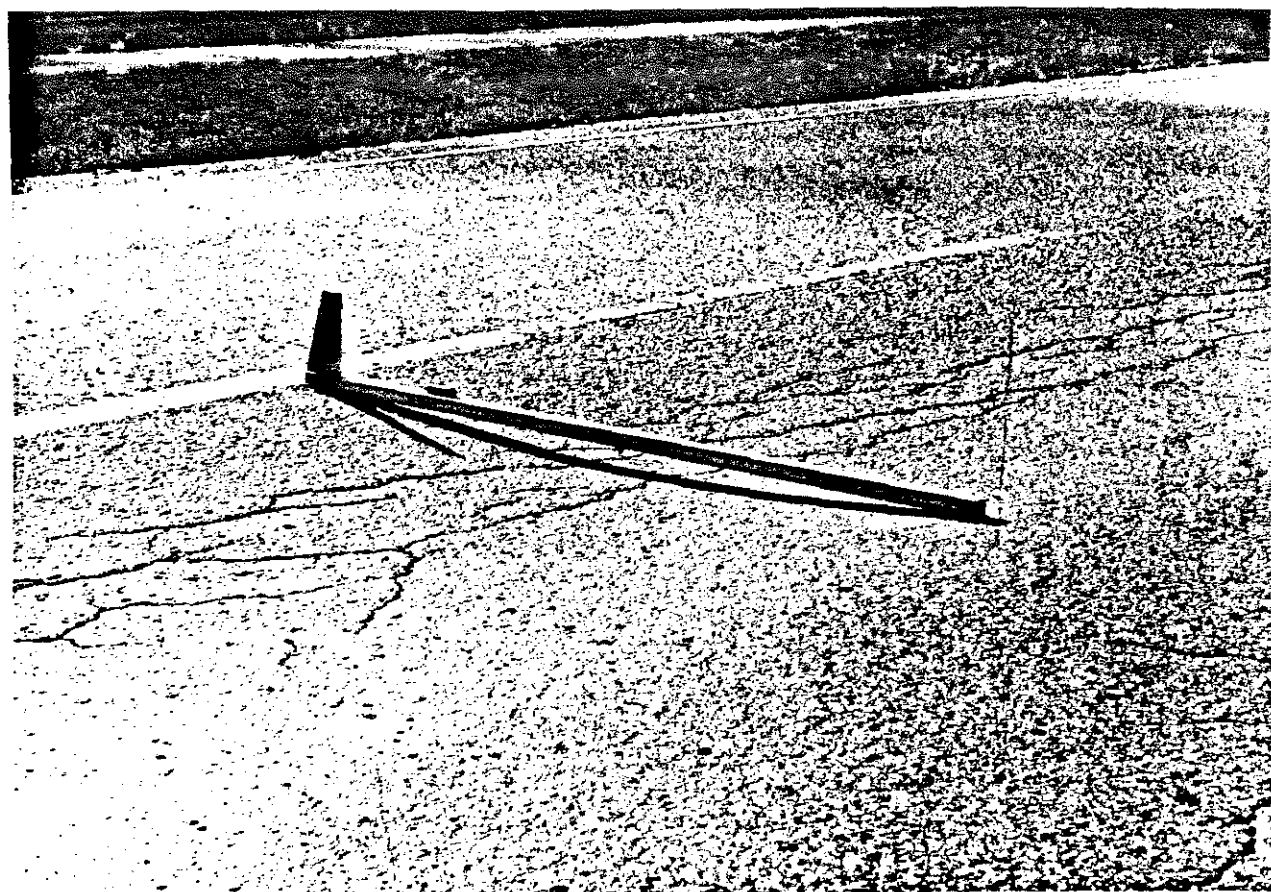
The shear mode is evident. Maximum shear tends to occur at a depth equal to one-third the radius of the loaded area. Assuming the diameter to be 30 inches (the approximate width of the rutted wheelpaths), the

Figure 5. Typical Cracking Pattern Accompanying Rutting in Wheelpath on  
I 64, MP 164, December 4, 1979 (8, 9).

depth of maximum shear would be 5 inches. Punching shear may suffice to explain longitudinal cracking at the edges of the wheelpaths. Maximum shear may explain eventual checkering and map cracking within the wheelpaths. Kneading shear in the wheelpaths together with punching shear at the edges progresses little by little. These concepts are illustrated diagrammatically in Figure 6. A crushed rock base may be as strong after deformation as it was before deformation, and the foundation soil may not be critically weakened until slip planes develop or swelling due to water infiltration occurs. An example of early failure exhibiting a longitudinal crack pattern is shown in Figure 7. There, failure occurred within a few months of service, it was attributed to gelled clay in the foundation (site was trenched and evaluated). Subsequent overlayment hid and adequately bridged over the short section involved. Heavy hauling may have abated also.

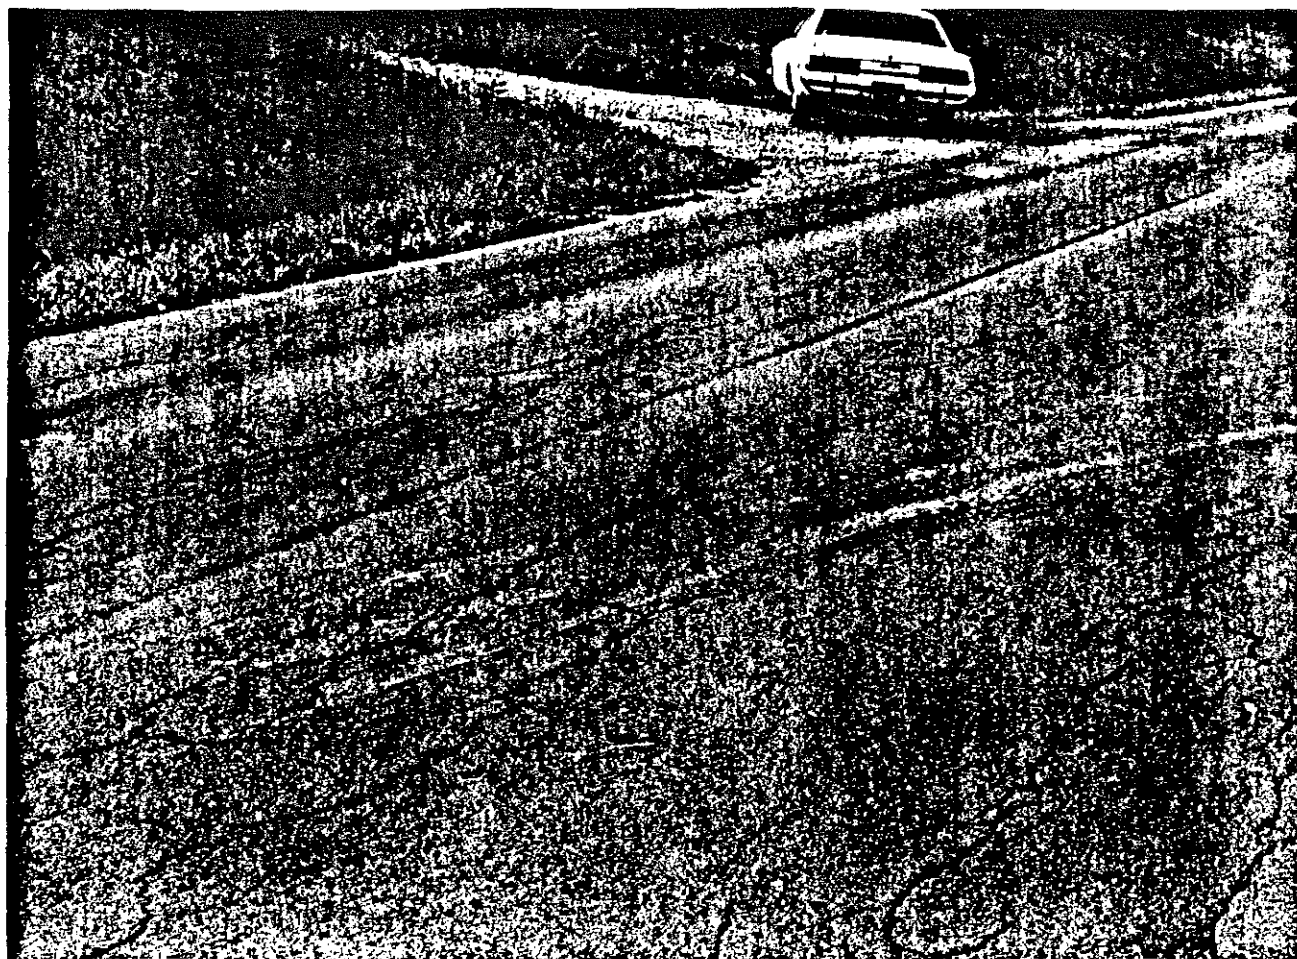
Figure 7. US 62, Harrison County, SP 19-112-10C1, September 19, 1979, Wheelpaths Cracking (Longitudinal), 8.5 Inches of Asphaltic Concrete. Cracking occurred about 6 months after construction. There was heavy hauling in both directions. Section shown above was trenched later in 1979. The soil underneath was a gelled clay that gave only spongy support. Cracks were recognized as the punching-shear mode of failure.

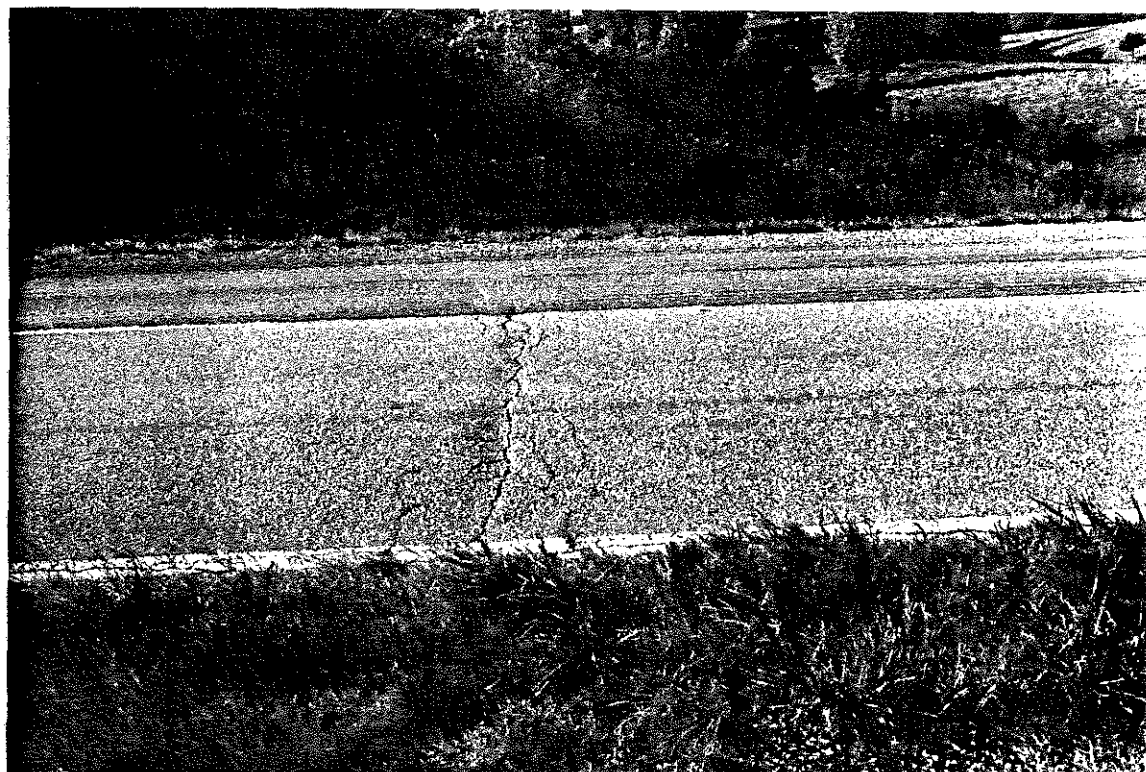
Cracking: Example of Prominent Crack;  
Section Chip-Sealed; Not Bleeding (10-10-85)

2. Temperature (transverse) cracks probably should not be sealed. The overlay will suffice structurally, but the transverse cracks will reflect through and be unnoticed for a time.

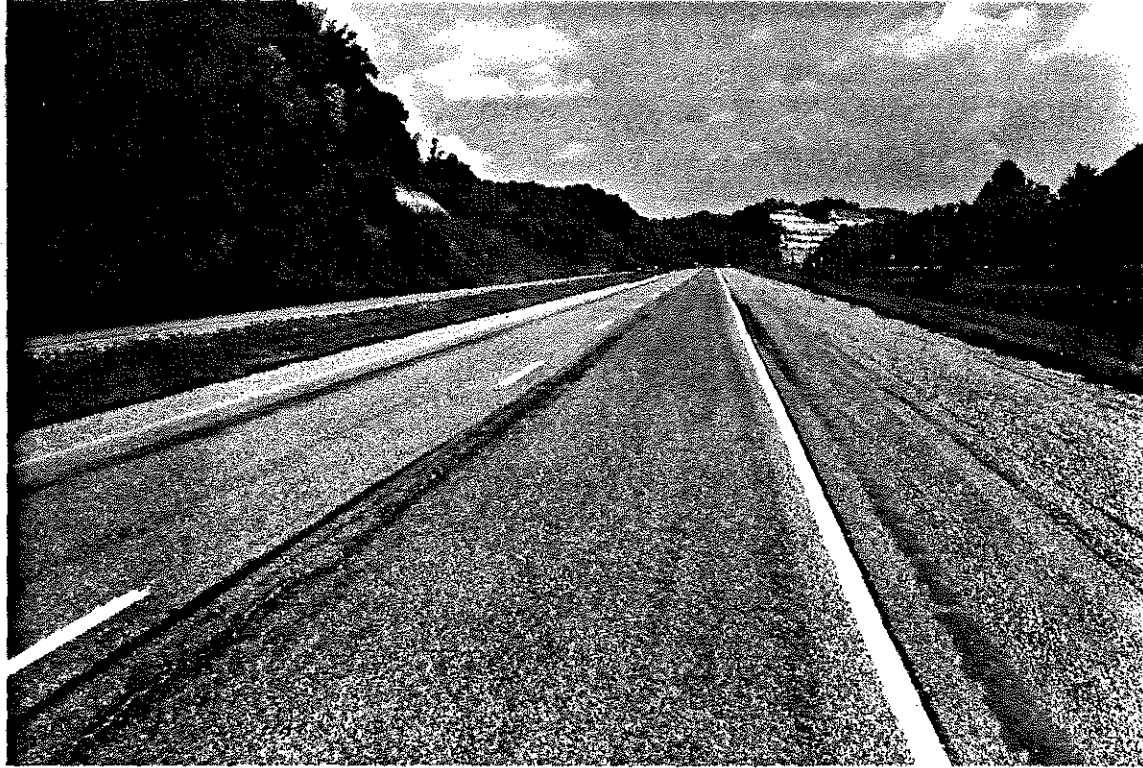
Section toward South Shore; Chip-Sealed  
Aggregate Loss Seems Extensive (10-10-85)

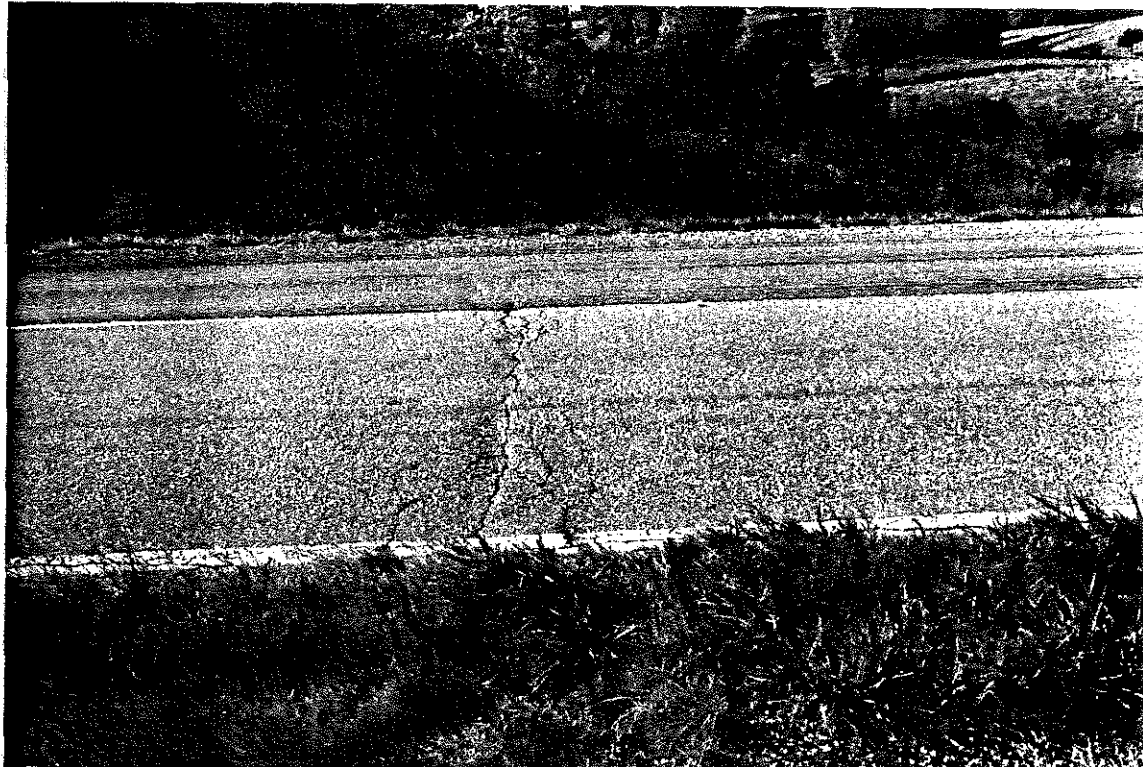
Cracking: Example of Prominent Crack;  
Section Chip-Sealed; Not Bleeding (10-10-85)

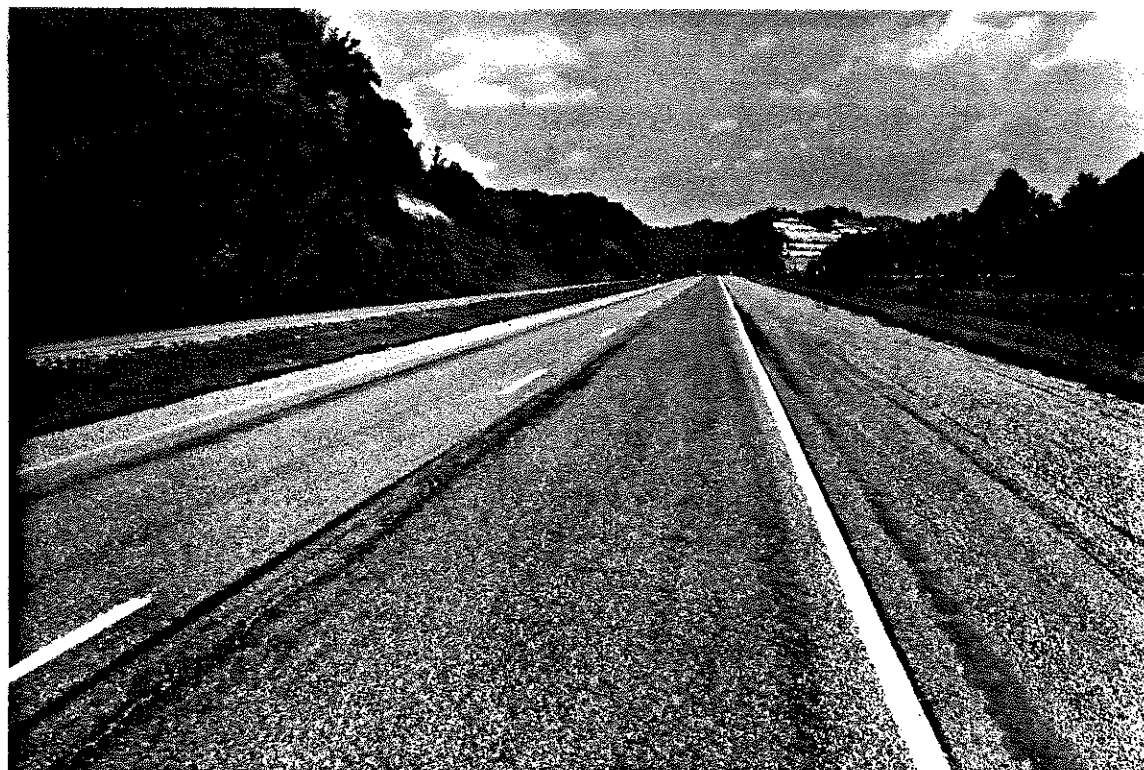
Section toward South Shore; Chip-Sealed  
Aggregate Loss Seems Extensive (10-10-85)

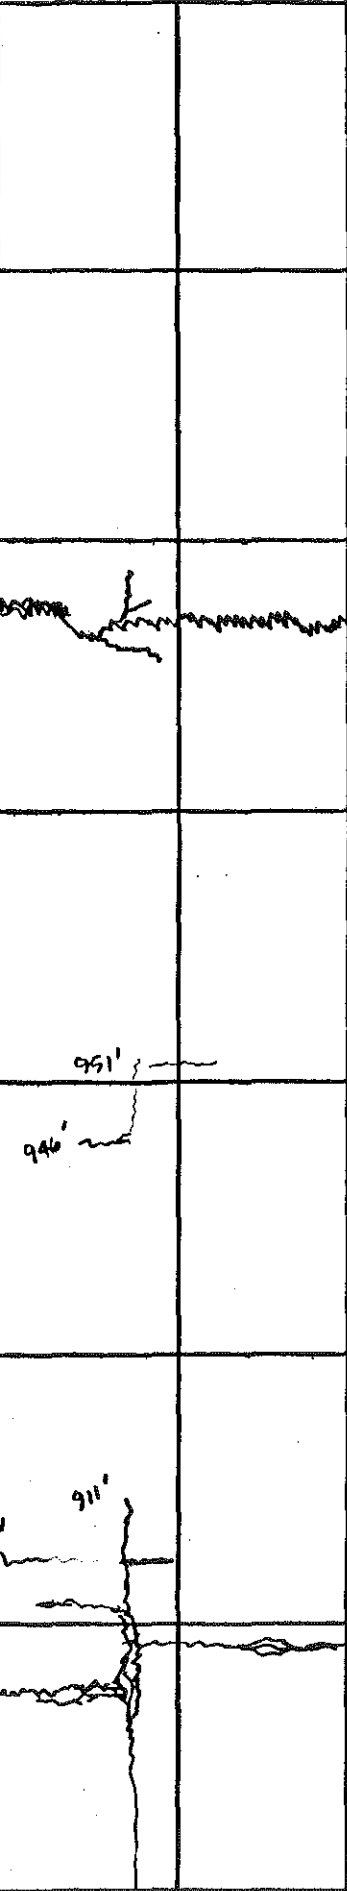
U.S. 23 GREENUP COUNTY  
DESIGN SECTION D

END SURVEY  
1000  
photo # 869  
991'  
CAN SEE SUBBASE  
THRU CRACK -  
CRACK R'D ACROSS  
TWO LANES  
975

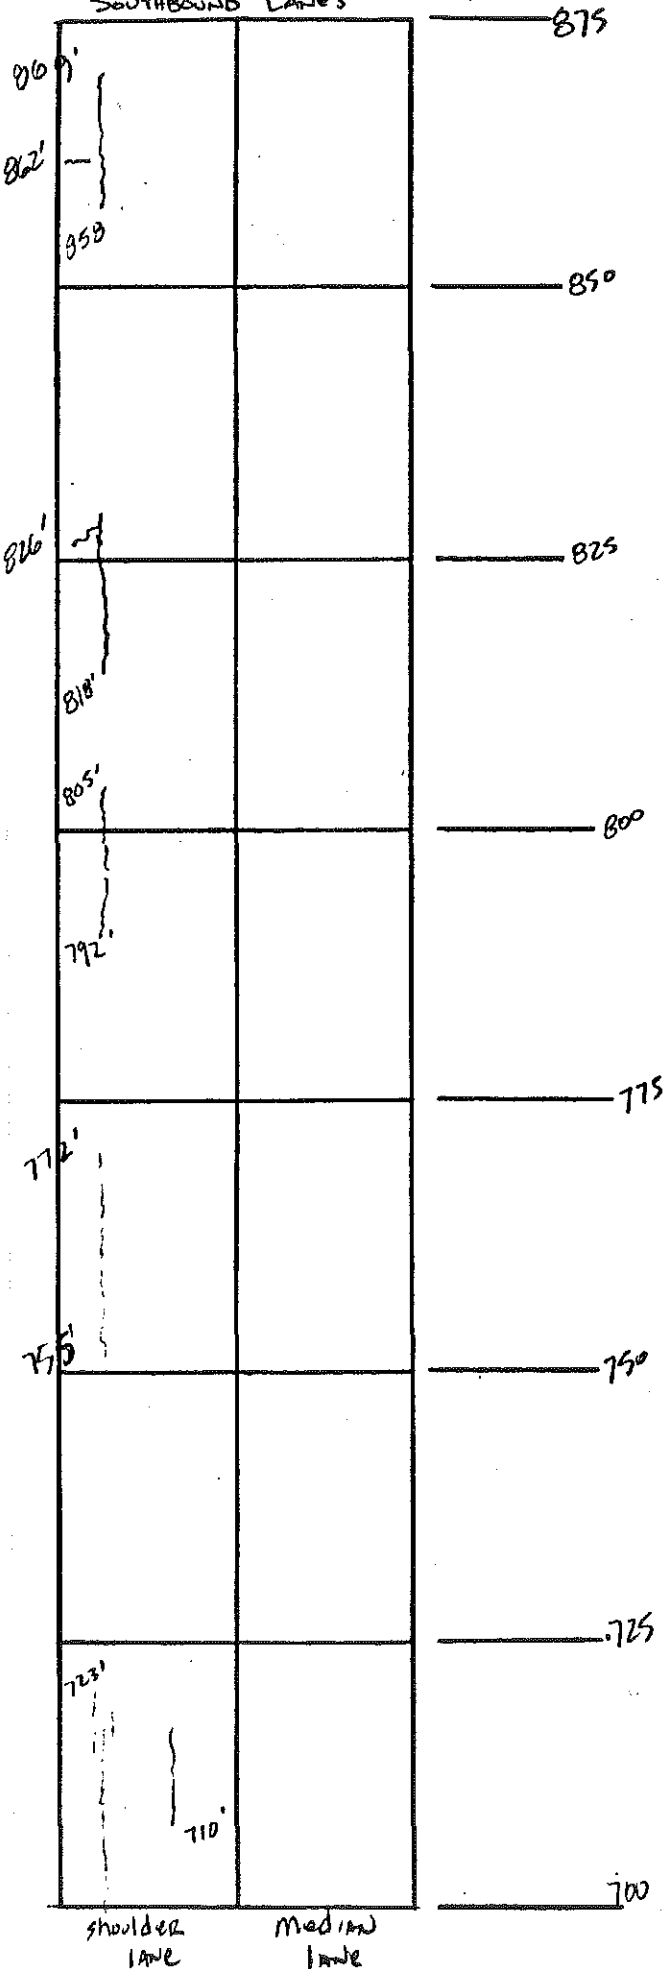
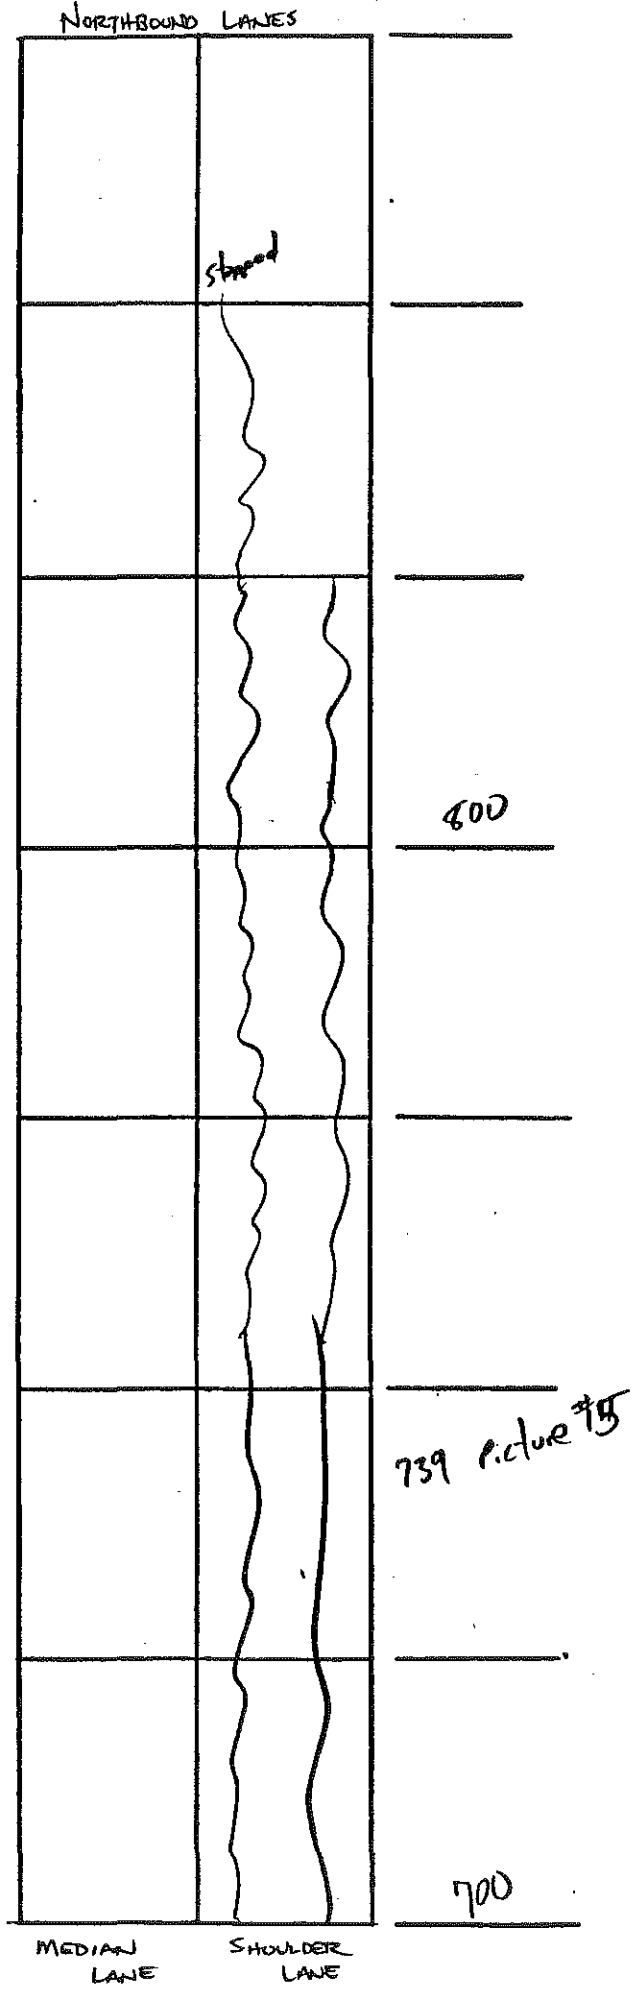
U.S. 23 GREENUP COUNTY  
 DESIGN SECTION G  
 SOUTHBOUND LANES

Note: Limestone surface in good shape  
some putting in shoulder lane. surface  
appears newer & in much better  
shape than NB lanes

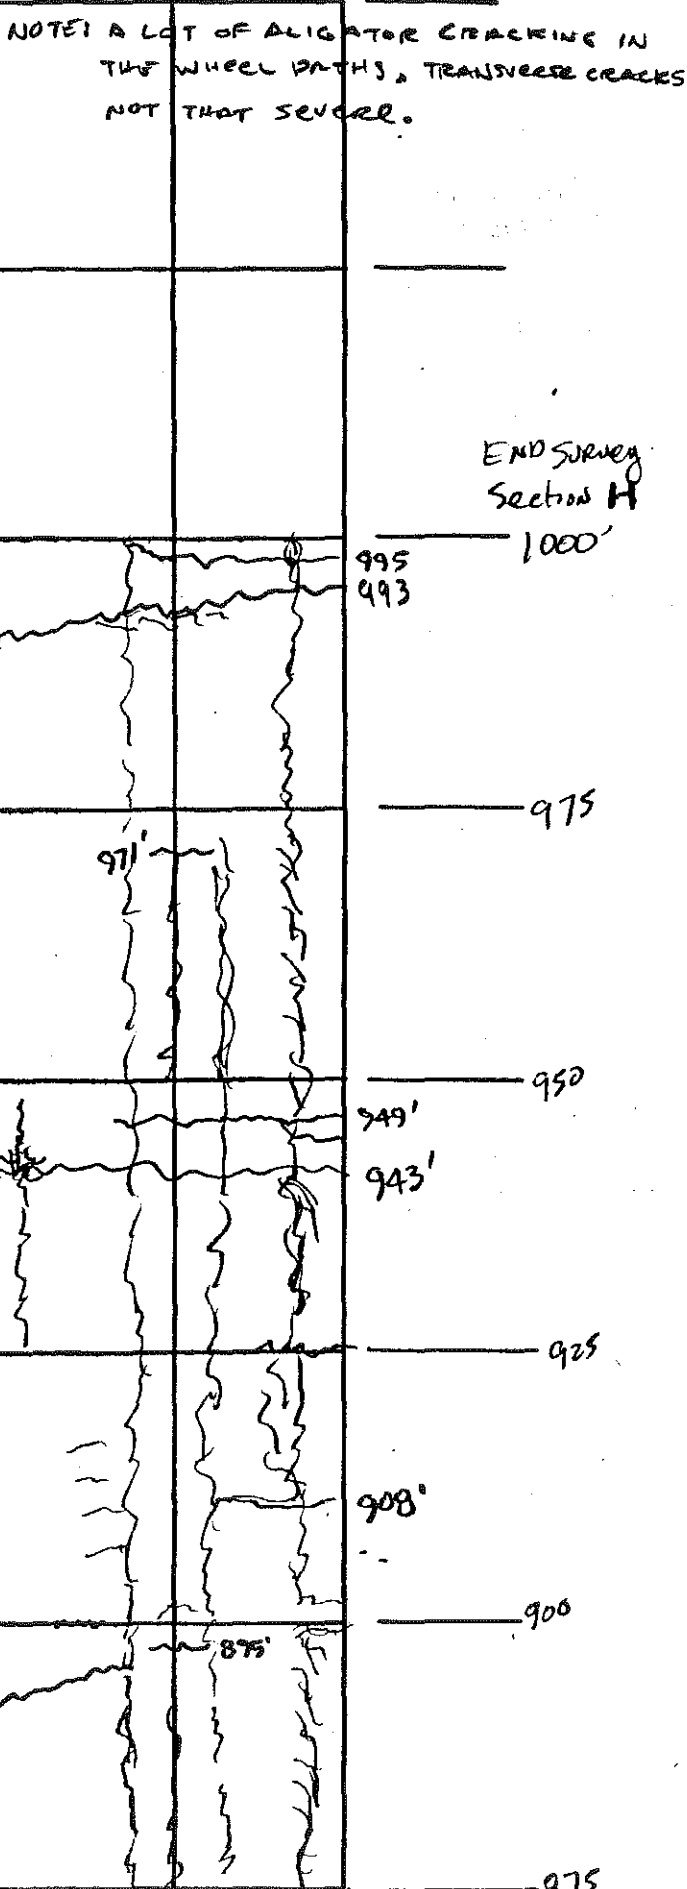
U.S. 23 GREENUP COUNTY  
DESIGN SECTION H

NOTE: A LOT OF ALLIGATOR CRACKING IN  
THE WHEEL PATHS, TRANSVERSE CRACKS  
NOT THAT SEVERE.
